**Katz Family Home Inspection,LLC**

# Home Inspection Report

Friday January 1, 2021

12.res.24.LL.01

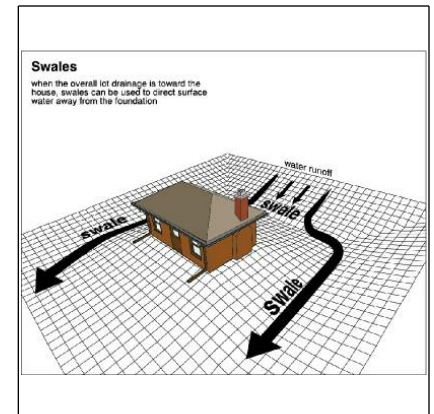
**Comments** Completely covered with snow. May have a slight negative grade towards the house.

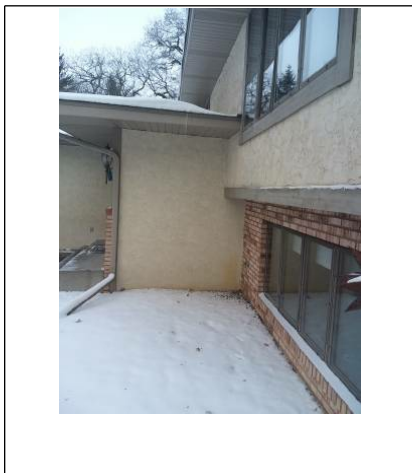
Noticable area of cracking on the east side of the house.

The stucco appeared to be in good condition with minimal cracking. What cracks there are should be sealed and then painted.

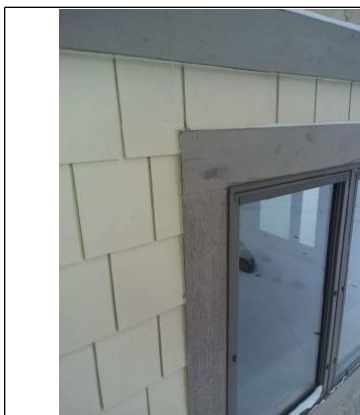
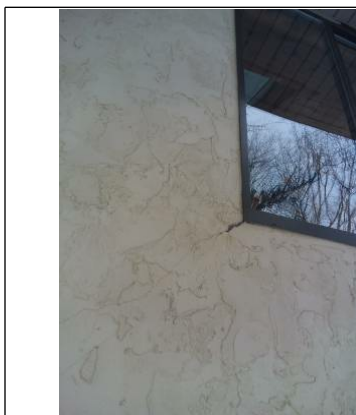
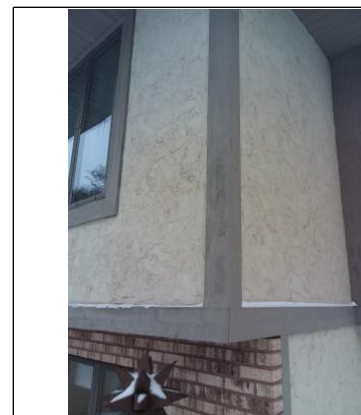
**Comments** Wood trim around windows and doors appear to be in good condition with only minor decay in one or two areas and one area with woodpecker damage.

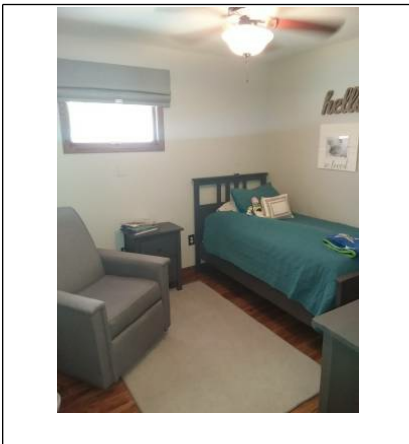
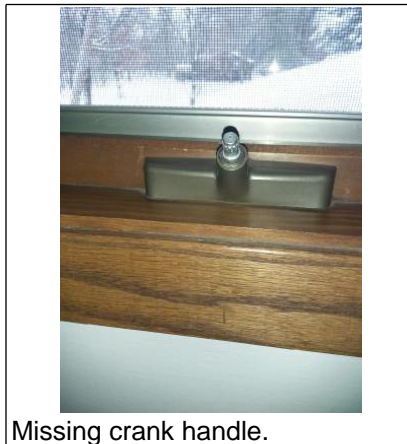
**Comments** Linda wins the prize for the correct answer. The room is not considered a bedroom because the window does not meet minimum requirements:  
5.7 sq ft of operable glass area when not at grade.  
Must be a minimum of 24"x20".  
Can't be higher than 44" above the floor.

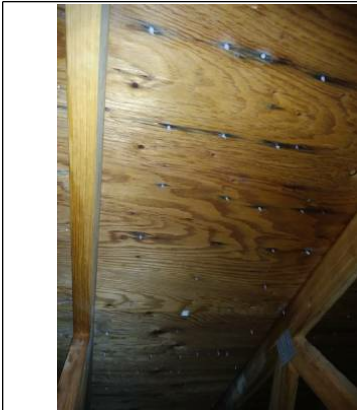
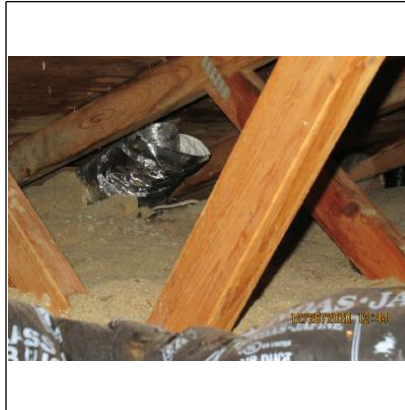
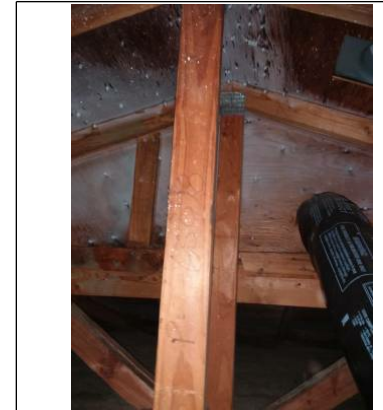
It is very possible that when the roof was replaced three years ago the roofers did not properly attach the vent fan ductwork. This is a reasonable time frame to account for the rust on the roof shingle nails.

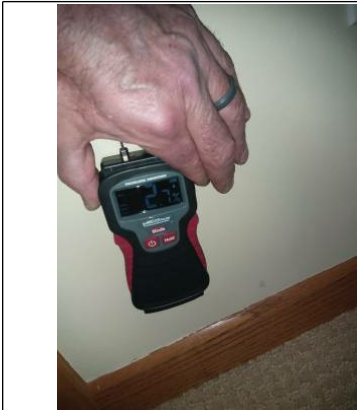
Moisture readings were very low.  
This is a good thing.

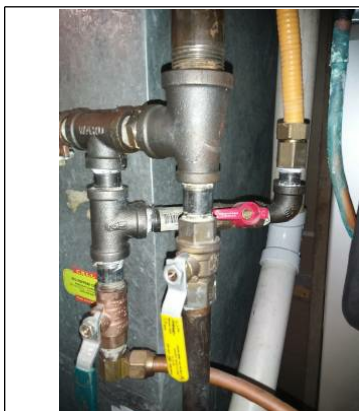
**Comments** CSST gas line is not bonded. It would not be difficult to add a bonding wire.

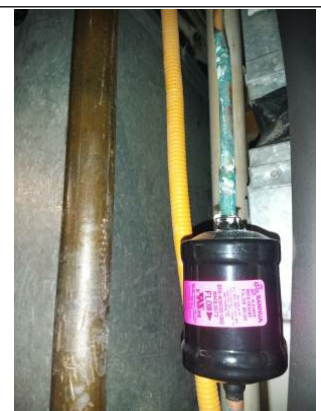
Filter dryer showing some signs of corrosion. I would monitor this.

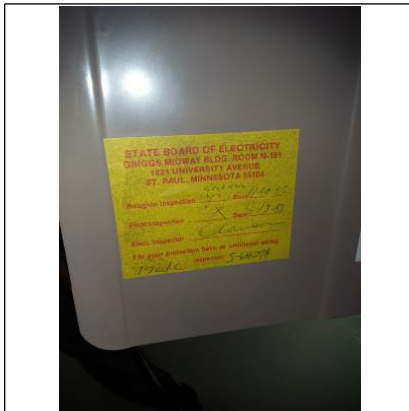
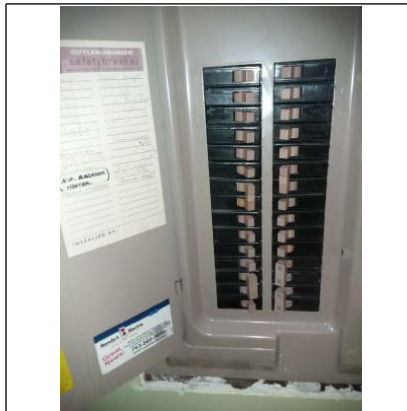
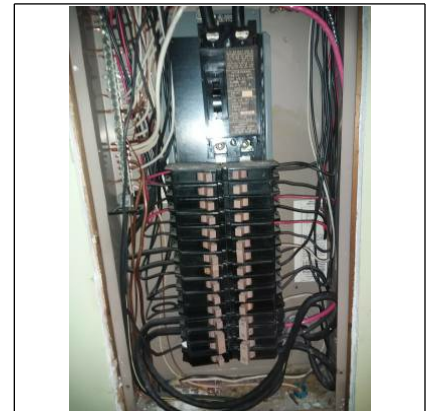
Panel is original to the house. It is old, but in good condition.

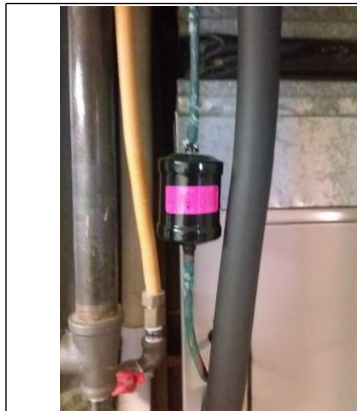
Filter dryer showing some signs of corrosion.
