**Katz Family Home Inspection,LLC**

# Home Inspection Report

Friday January 1, 2021

12.res.24.LL.01

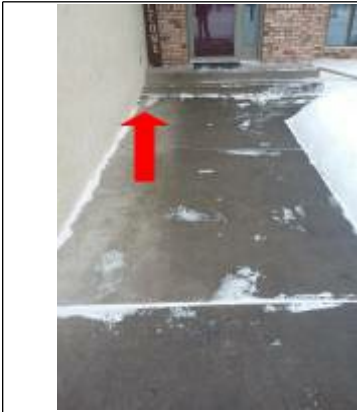
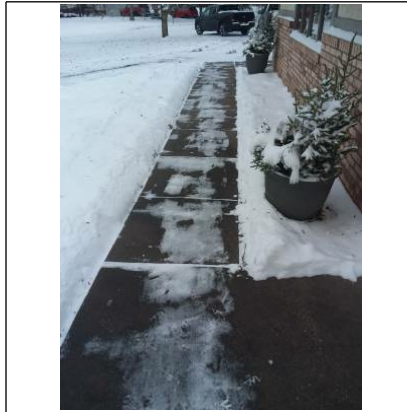
**Comments** Some settling at the side of the garage and below the bottom step. I would monitor this.

Slight area of settling.

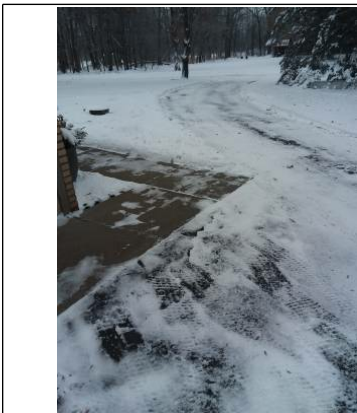
The driveway is pitched away from the house.

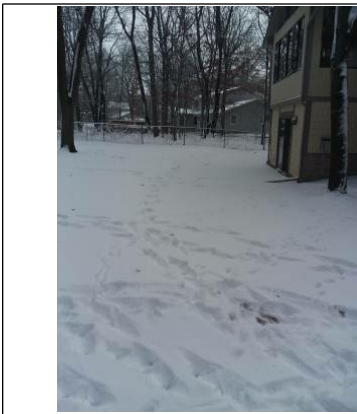
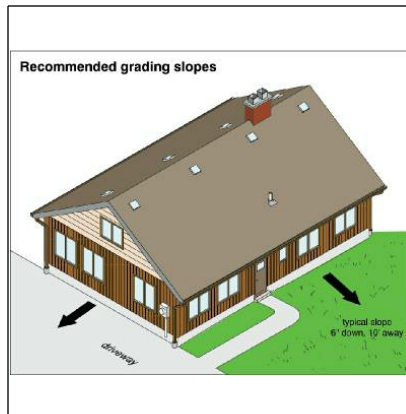
**Comments** Completely covered with snow. May have a slight negative grade towards the house.

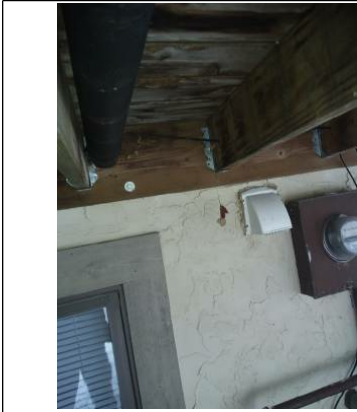
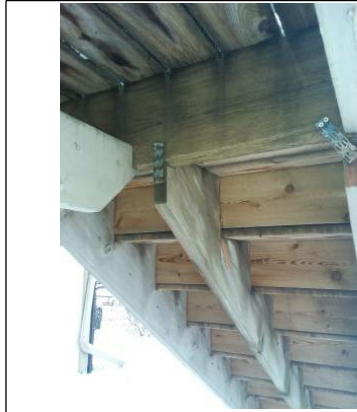
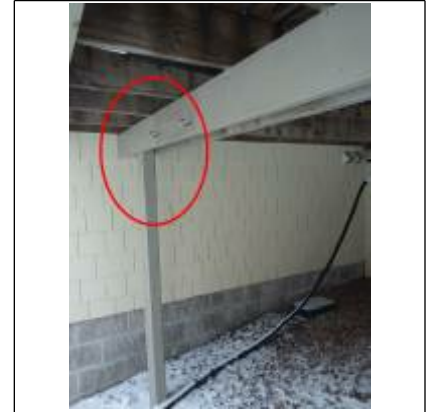
Beam attachment to the post is improper.

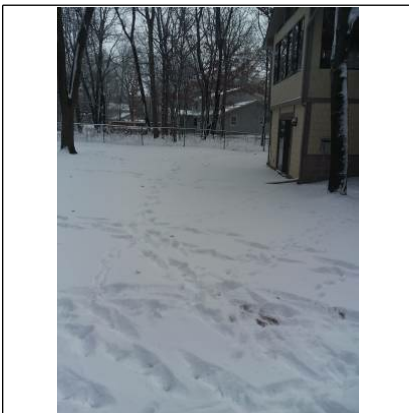
I would monitor the area at the back slider for runoff problems come spring.

**Negative Grade And Recommendations** ☐ East ☐ West ☒ North ☒ South ☐ Satisfactory  
☒ Recommend additional backfill ☐ Recommend window wells/covers  
☒ Trim back trees/shrubberies  
☐ Wood in contact with/improper clearance to soil

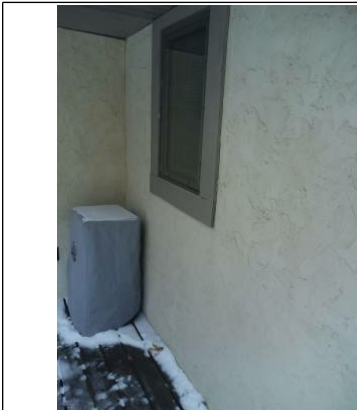
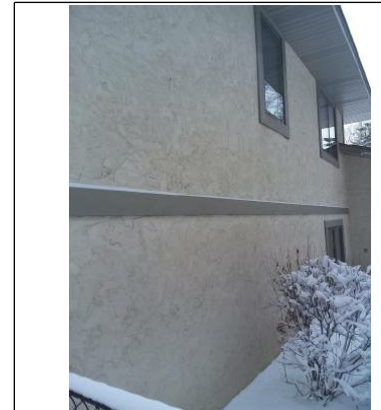
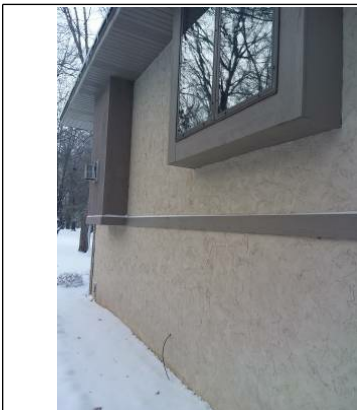
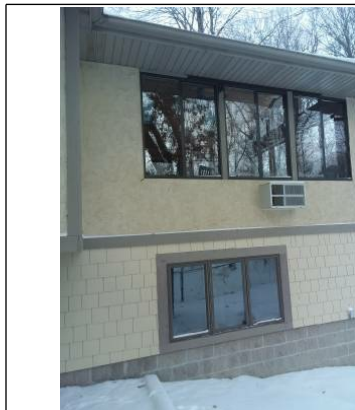
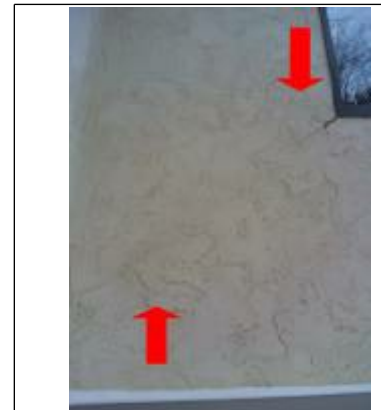
The stucco appeared to be in good condition with minimal cracking. What cracks there are should be sealed and then painted.

Noticable area of cracking on the east side of the house.

Caulking should be checked regularly around windows and doors.

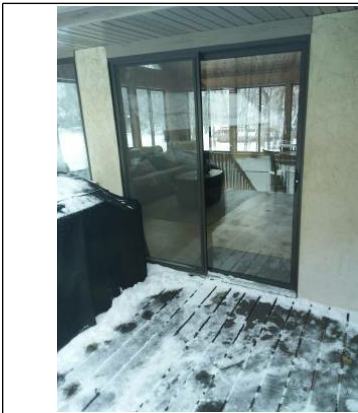
Small screen tear on slider door off of the sunroom.

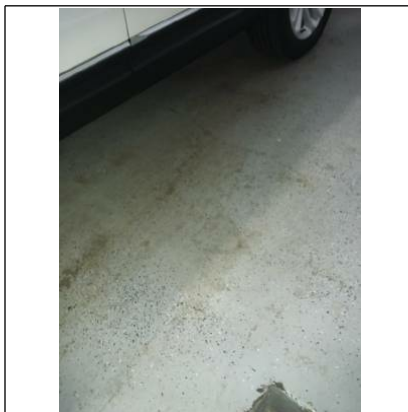
**Condition** ☒ Satisfactory ☒ Typical cracks ☒ Large settling cracks ☐ Recommend evaluation/repair  
☐ Safety hazard

**Comments** Larger settling crack in attached garage. These cracks should be filled with self leveling concrete caulk.

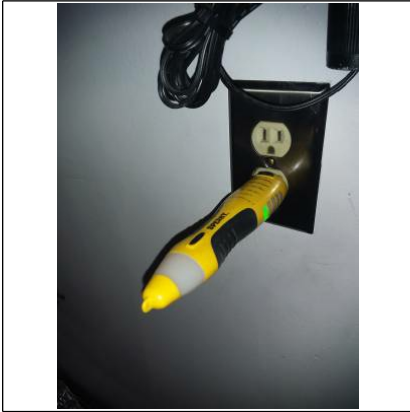
**GFCI Present** ☐ Yes ☒ No Operable: ☐ Yes ☒ No ☐ Handyman/extension cord wiring  
☒ Recommend GFCI Receptacles

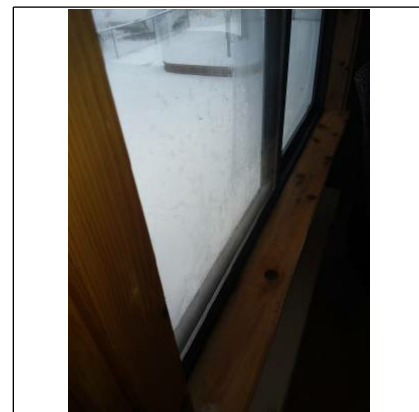
**Windows** ☐ None ☐ Satisfactory ☒ Marginal ☐ Poor ☐ Cracked glass ☒ Evidence of leaking insulated glass  
☐ Broken/Missing hardware

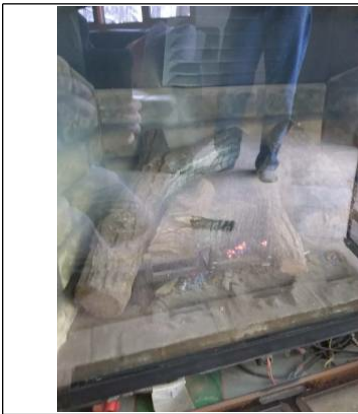
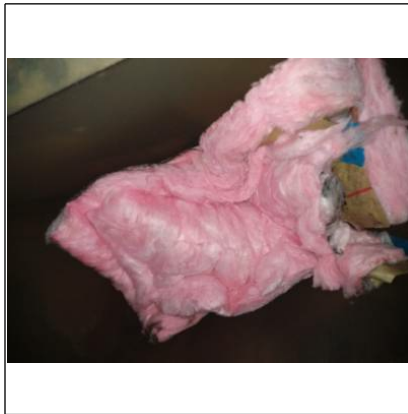
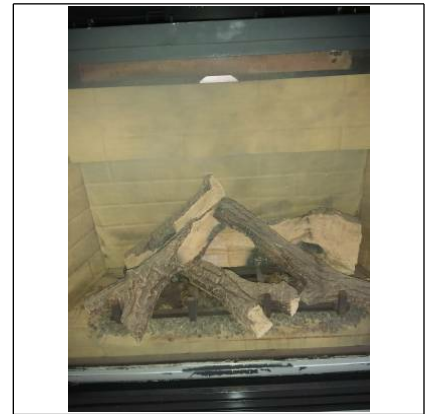
Both gas fireplaces did not have any obvious issues. Fire box and flames on both were acceptable.

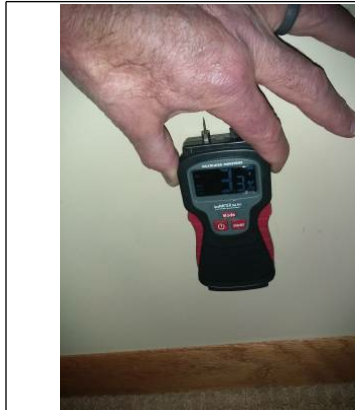
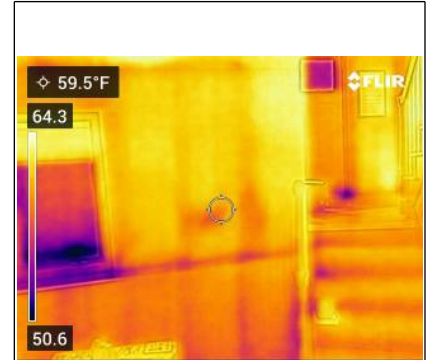
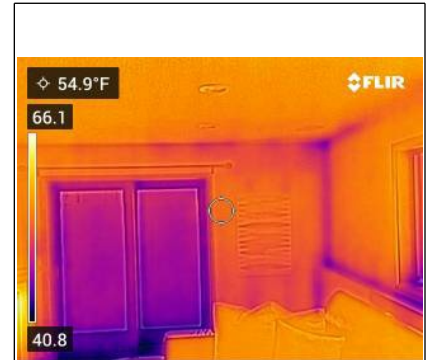
Moisture readings were very low.  
This is a good thing.

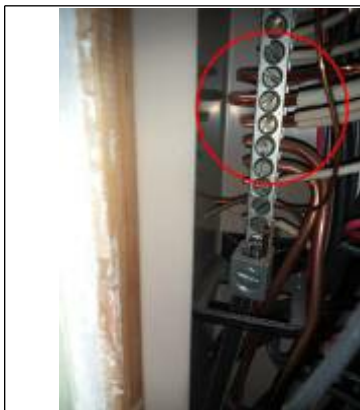
Two neutral wires under one screw (lug) does not meet current standards.

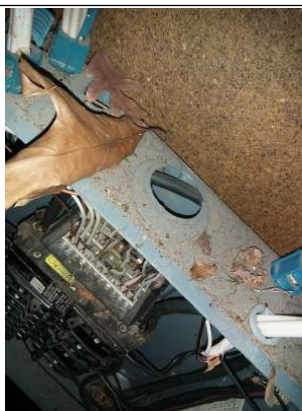
Knock out holes should be covered.

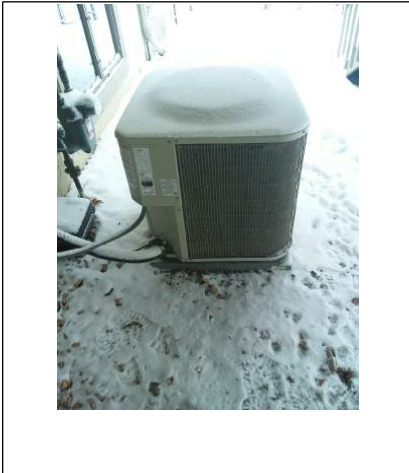
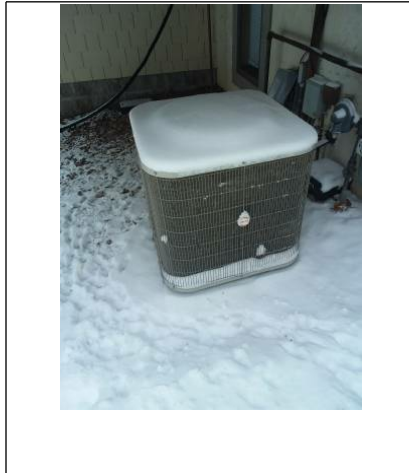
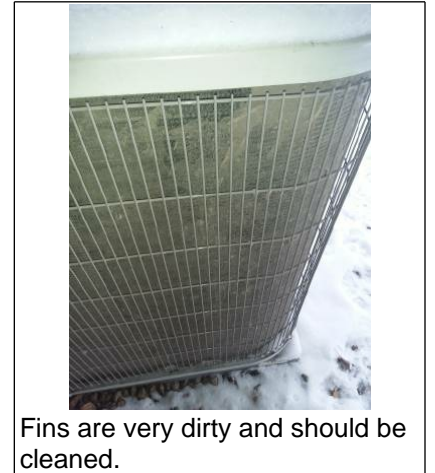
Fins are very dirty and should be cleaned.
